Failure of turbocharger, whistling noises and lack of performance**Please note:**

Vehicle manufacturer: BMW

Validity: This service information is valid for the exchange of the turbocharger with **BTS reference:** T914870;

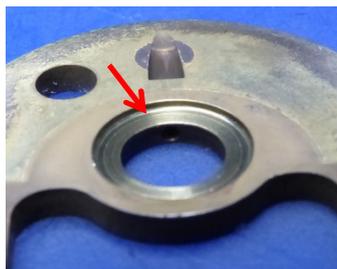
If the turbocharger on the vehicles below fails after being exchanged, the exhaust back pressure is most likely too high, leading to a damage on the axial bearing of the rotorshaft. The damage on the turbocharger usually results in an extremely increased axial bearing clearance, leading to the turbine wheel grazing on the heatshield of the turbine housing and the compressor wheel grazing on the compressor housing. The driver will probably notice shrieking whistling noises and a starting lack of performance.

Axial bearing
worn by axial thrust

turbine wheel –
grazed on housing

compressor wheel –
grazed on housing

Insert a T connector along with a hose and a manometer before the DPF on the test pipe. The measured exhaust back pressure may not exceed **300 mbar** in any rpm range when testdriving the vehicle – already under operating temperature. Please also refer to the 4th issue of our Technical Guide for additional information. We also offer relevant equipment for the measurement, our reference: **MESS01**.

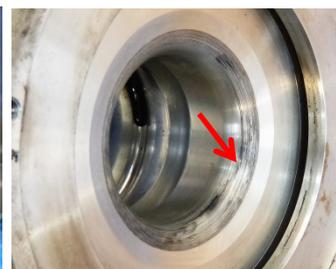
abraded compressor
housing
